# Manhole Inspection Summary

Manhole # S15C1\_014MH

Insp Date: **5/28/08 10:48 AM**

**Location** Address: **2930 james st**

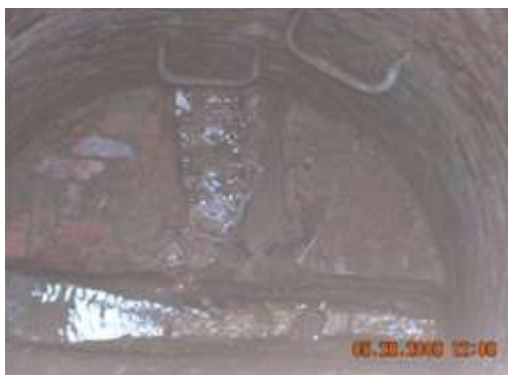
Defect 2

Condition: ☐ Sound ☐ Cracked ☐ Root Intrusion ☒ **Deteriorated** ☐ Leaks ☐ Debris

deteriorated bench @ 3 o'clock

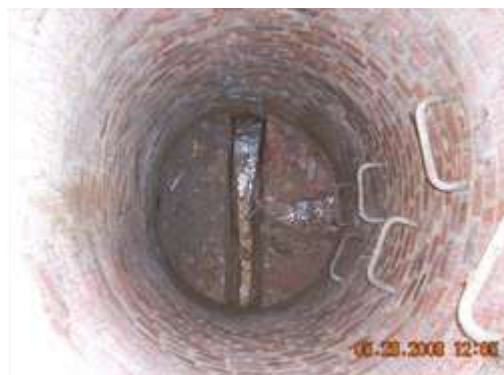
Defect 3

**Frame** Offset: **0** (in.) Condition: ☐ Sound ☐ Cracked ☒ **Leaks**

frame leaks-sheeting evidence

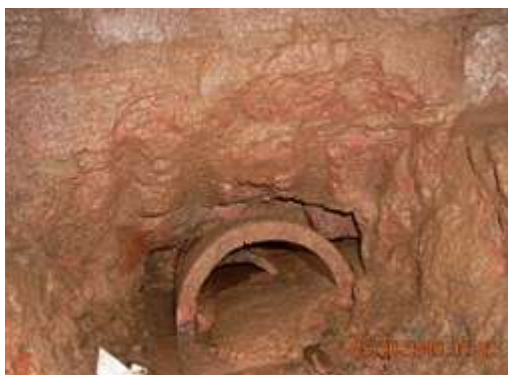
Defect 1

Condition: ☐ Sound ☐ Cracked ☐ Root Intrusion ☐ Loose Brick ☒ **Deteriorated**

3 o'clock break in; deteriorated barrel wall

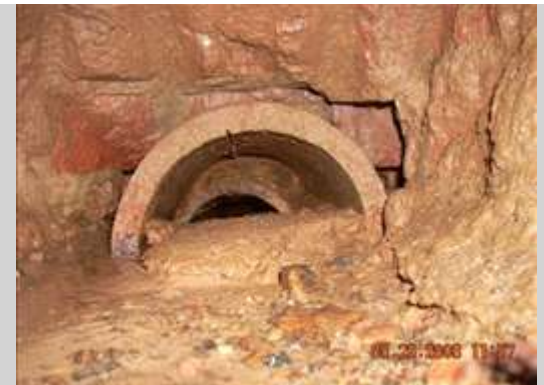
3 O'Clock Inflow

Deposits: ☐ None ☒ **Mud** ☐ Sludge ☐ Debris ☐ Grease

Silt Depth: **5** (in.) Deposits Extent: **Heavy**

Infiltration: **Evidence** Pipe Seal Cond: **Broken**
